## REVIEW OF RESPONSE TO COMMENTS ON WORK PLAN ADDENDUM ONE FOR MISSION TRAILS EQUESTRIAN CENTER, EAST ELLIOT, CAMP ELLIOTT, SAN DIEGO, CALIFORNIA

**Interim Quality Assurance Audit Evaluation**  
**On**  
**Global Mapping System's Digital Geophysical Survey**  
**For the**  
**OE Construction Support Project**  
**At the**  
**City of San Diego's Construction Site**  
**Mission Trails Equestrian Staging Area**  
**Located on the**  
**Formerly Used Defense Site (FUDS)**  
**Camp Elliot-East Elliot (J09CA006703)**  
**Mission Trails Regional Park, San Diego CA**

**July 28, 2003**

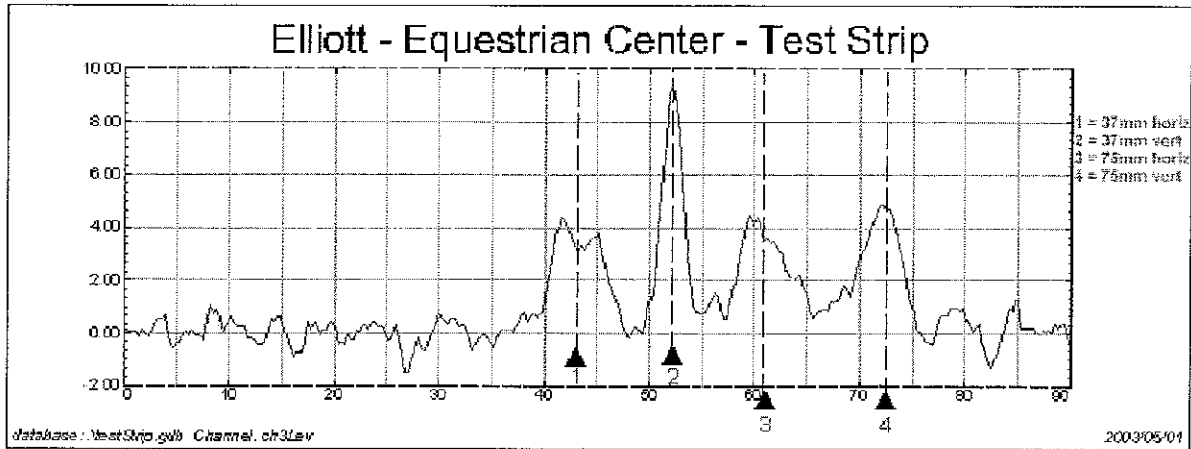
**Figure 3: Test strip profile plot (vertical scale is Channel 3 reading in mV)**

**QA Comment:** The seed item locations for the test strip appear to be inaccurate based on the responses seen on the attached profile plot. The higher amplitude, sharper peak response seen for seed item 2 is more consistent with a vertical orientation than horizontal. Likewise, the double peak response evident in seed item 1 is more consistent with a horizontal orientation.

**Response from GMS:** *The order and orientation of the seed items in the test strip were transmitted incorrectly. The correct position and orientation of the test strip items is shown in the attached Teststripfinal.shp and Teststrip1.pdf files.*

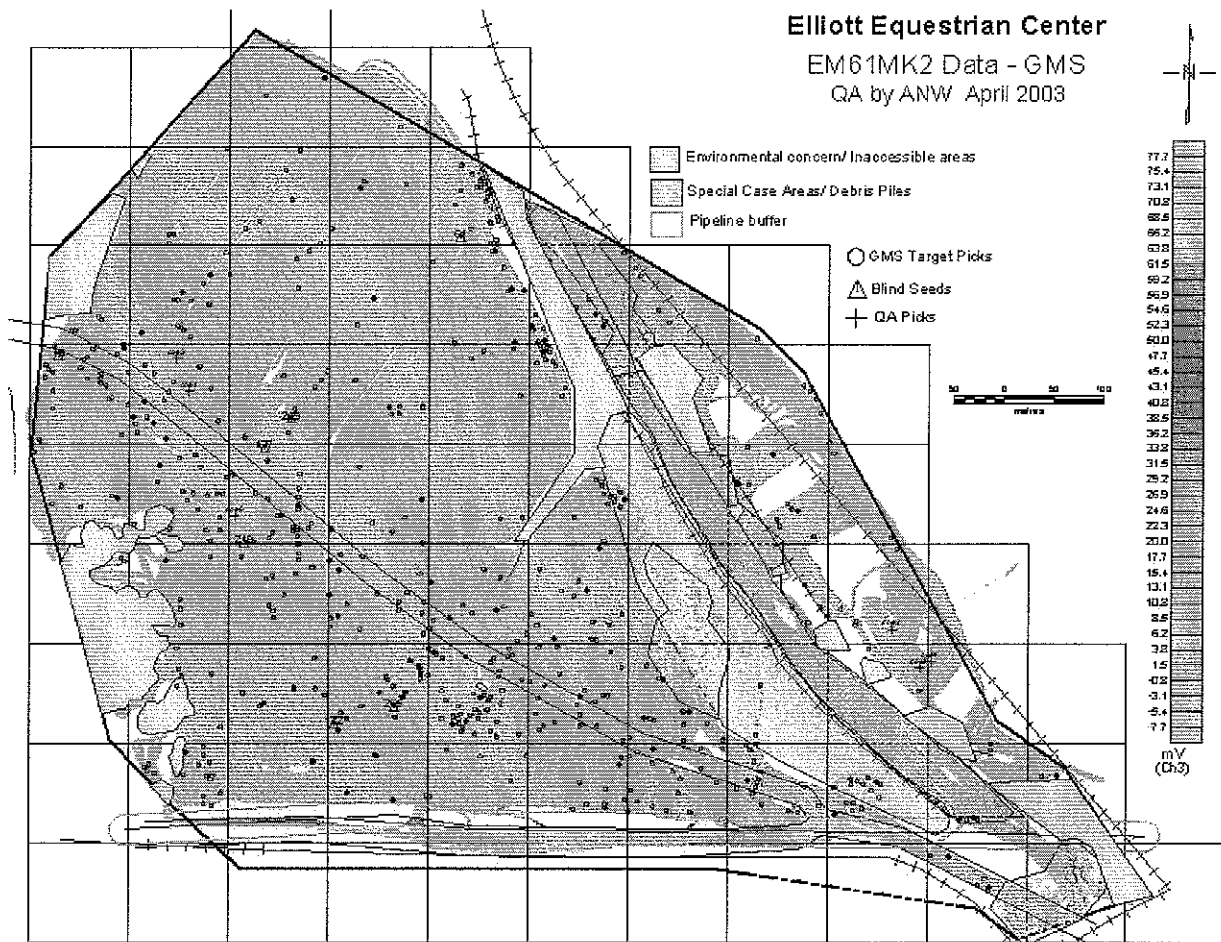
**Figure 4: Geophysical Data Map** (from original exclusion area Shape Files)

From this review, the overall data quality, noise levels and navigation look good. An Interim QA Report was sent to the project PM by email on May 1, 2003. The following are the problems/concerns relating to Geophysical Mapping Data that were addressed in the interim QAR, and their resolutions received on May 18, 2003:

- (1) **QA comment:** There appears to be large areas of missing data. Attached is a data map, the blue areas are known environmental concern/inaccessible/special case areas and the white is data gap areas (large areas on the east side and south of the pipeline). The data gaps (white areas) could be caused by several factors: (1) the

areas are inaccessible or environmentally sensitive and removed from the geophysical coverage area, (2) the data was collected, but not transmitted on the data CD, or (3) the data was not collected and is still needed to meet project objectives. It is entirely possible that I don't have complete information on which areas were to be mapped and that the first alternative is the correct one.

*To resolve existing data gaps, GMS plans to mobilize and collect the missing data at least 3 days prior to the reacquisition/anomaly investigation event, at no additional cost to the government. It is recommended that the USACE Biologist be available at this time to resolve areas located on the North slope.*

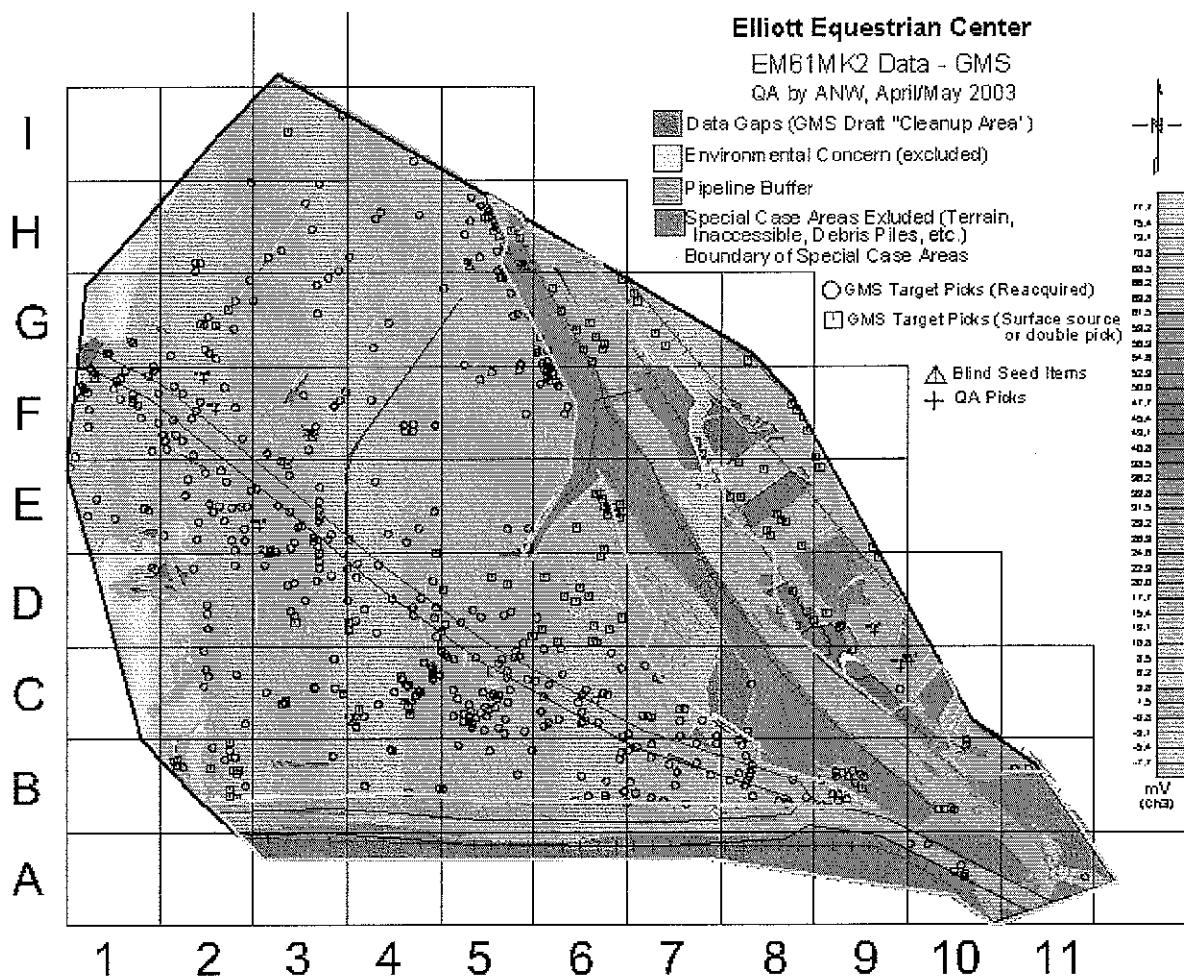
**Figure 5: Updated Geophysical Data Map** (with new shape files from GMS) – Data collected inside the Special Case and Pipeline Buffer Areas has been brought to the front of the map and is bounded by the light blue polygon. See section 2.5 for discussion of anomalies within this area.

The initial Cleanup Plan (red areas) does not address all of the data gaps due to increased lane spacing. It is the author's opinion that all of the red areas should be geophysically mapped and all target anomalies dug. In addition, all areas where the lane spacing exceeds 3 feet should be filled in. The original lane spacing of 2.5 feet was used to ensure that full coverage was obtained, giving some room for error in positioning and some coil overlap. Because of the physics and operation of the EM61 instrument, the detecting capabilities are focused inside the coil, with significantly decreased detection outside of the coil. This is especially important for small target items such as 37mms. Therefore, any lines whose across-lane spacing exceeds 3 feet (the width of the EM61 coil) should be filled in with additional geophysical data.

- (1) GMS provides a final “cleanup” plan for review, then maps and processes the data gaps, and addresses any detected anomalies. This includes all data gaps where the lane spacing is greater than 3 feet.
- (2) GMS provides an updated target list including the QA picks and excluding 95181, 9197, 9177, 9176, 9163, 9150, and 9195 (as discussed in the previous section). This updated target list should also include anomalies for investigation in the area outlined in blue in Figure 5.
- (3) All selected targets should be dug to ensure that the project area has been cleared to the best of our capabilities.

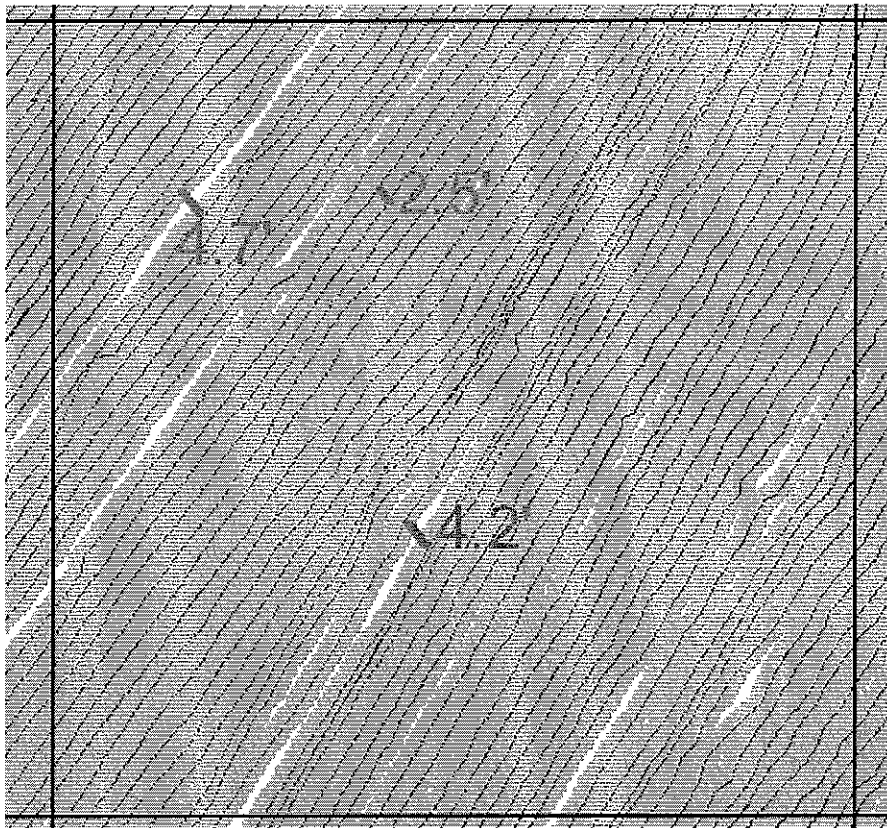
**Figure 6: Data Map Showing Example Lane Spacing**

- (2) **QA comment:** There are also numerous data gaps caused when the lane spacing objective of 25 feet is not being met. This could become a significant issue if 37mm's are found during intrusive work. Because of their small size, they could easily be missed with the larger lane spacing. It may be less significant if no OE is found during the initial intrusive work.

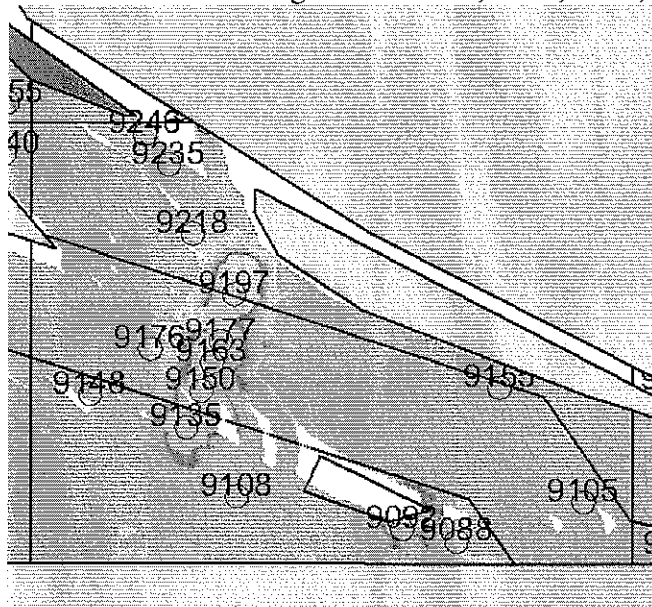
**Figure 7: Suspected culvert causing anomalies**

There are a few anomalies that were reacquired that should not be dug. First, anomaly number 95181 appears to be on the edge of an environmental concern area, and thus should be avoided. Additionally, some appear to be caused by a culvert beneath the road (in Grid B8). Recommend removing the following anomalies from the dig sheet: 95181, 9197, 9177, 9176, 9163, 9150, and 9195.

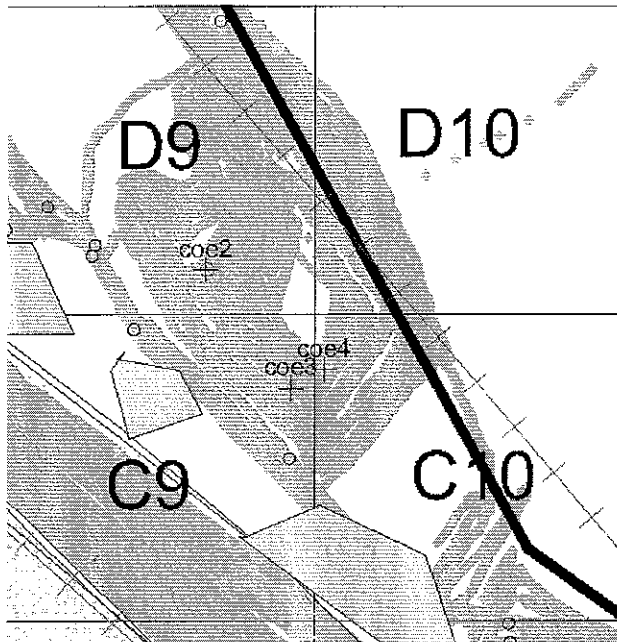
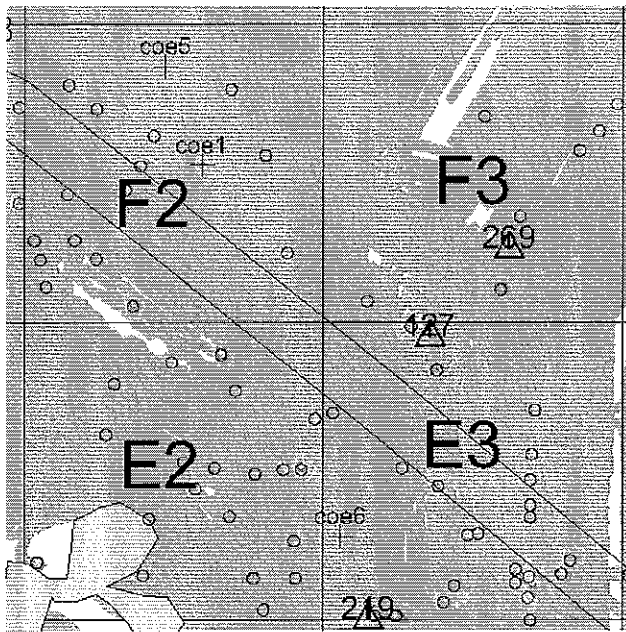
**Figure 8: QA Digs (shown by crosses)**

In addition to the targets selected and reacquired by the contractor, the government has made the following QA target picks. These targets should be reacquired and dug if no surface or cultural cause is detected.
